**Canadian Society of Civil Engineers,**

**NOTES ON RETAINING WALLS IN MONTREAL.**

By H. IRWIN, M.CAN.SOC. C.E.

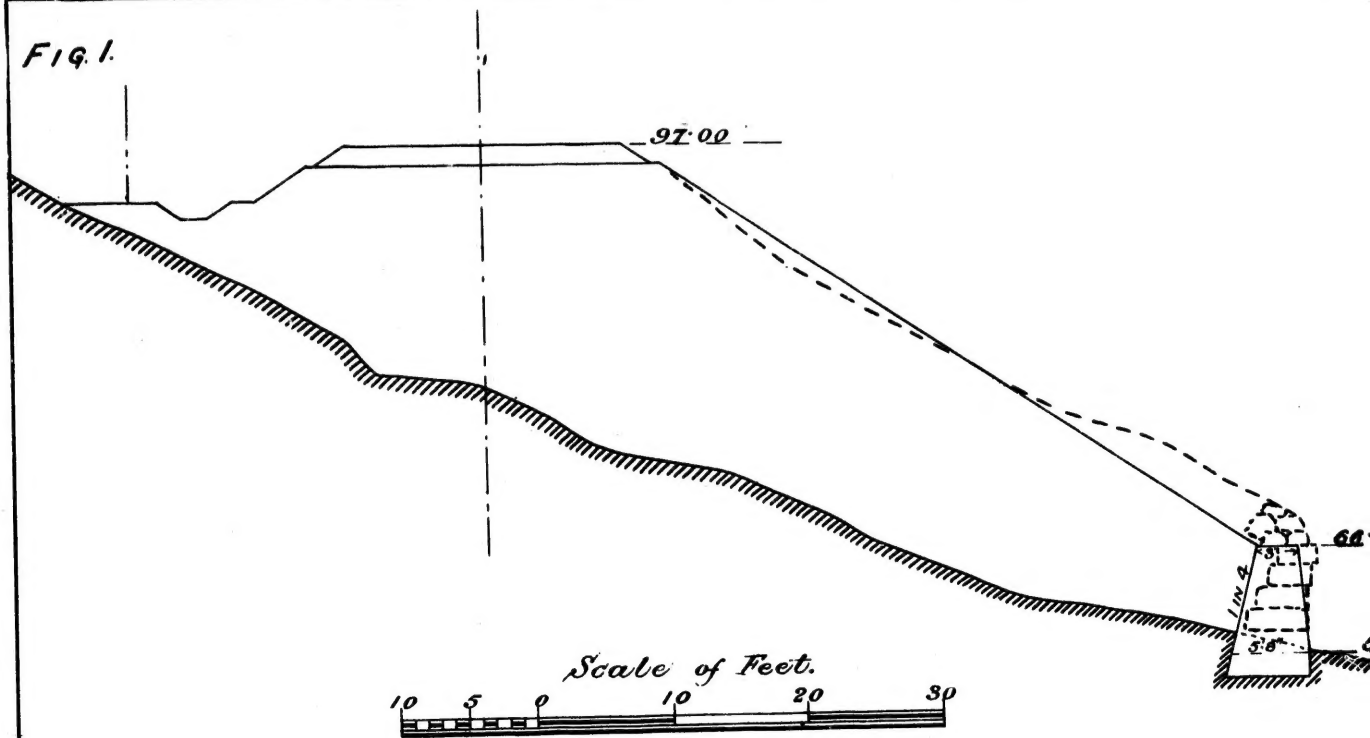
FIG. 1.

The wall shown in section by Fig. 1 is of dry masonry, built of stones from three feet to eight feet in length, by from ten inches to fourteen inches thick, the beds of the stones being fairly flat, but the back of the wall, in some places, seems to be rather poor, the stones being too small; the top front course was built with large, flat stones from five feet to eight feet six inches in length, but the writer has not been able to find out what proportion of through stones were used. The filling behind the wall is principally clay, a small proportion being earth and sandy clay, and was dumped from cars running on a temporary trestle.

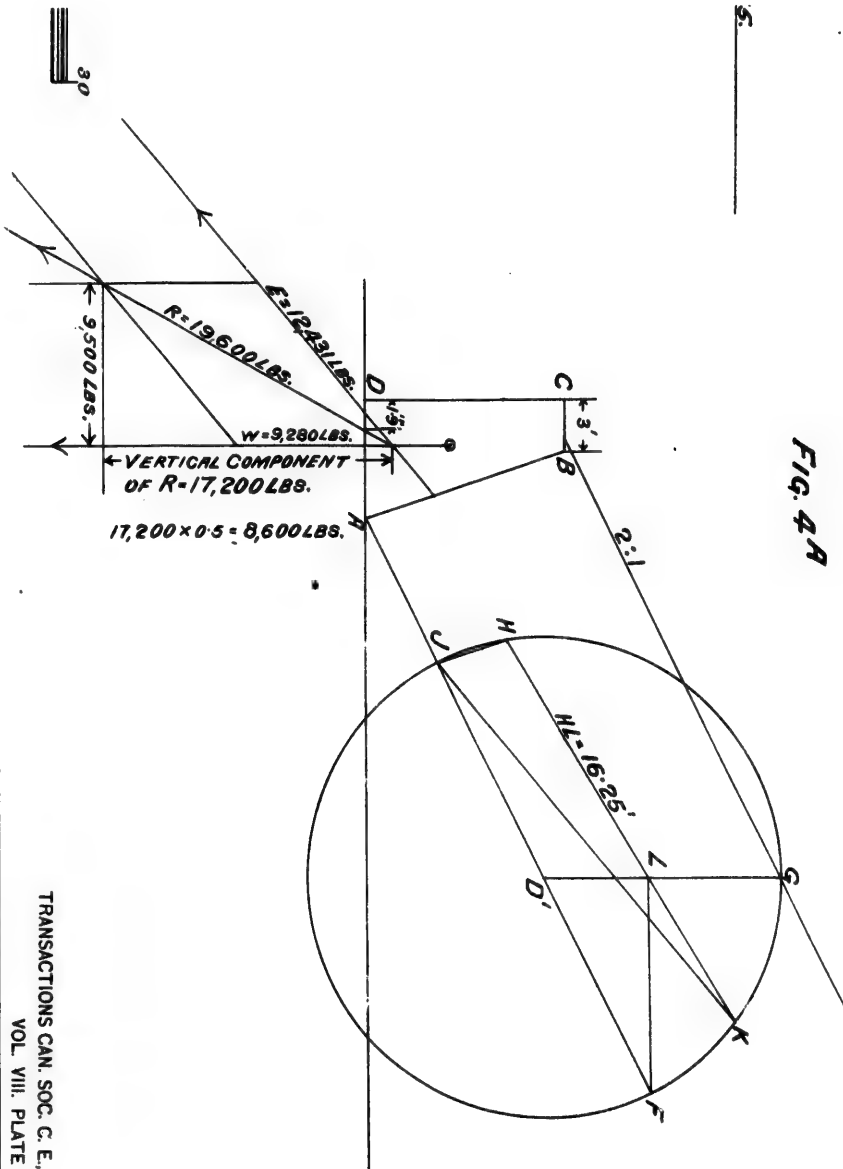
FIG. 4A

Fig. 4 A, drawn according to Weyrauch's theory, shews that the resultant pressure cuts the base at one-fourth of its width from the front corner, and the vibrations caused by trains should throw it still nearer the front corner, so that it is possible that the small forward movement of the wall was due to excess of pressure on the foundations. The horizontal component of the thrust is about half the vertical component of the resultant pressure; but the courses could not have slipped on each other, as the wall was built in Portland cement mortar.
